# Allied-Axis

THE PHOTO JOURNAL OF THE SECOND WORLD WAR

## Karl-Gerät 040 at the front

Panzerjäger I • SdKfz. 10 1-ton halftrack  
U.S. M2 Treadway Bridge • PzKpfw. IV Ausf. A  
Type 97 Japanese medium tank

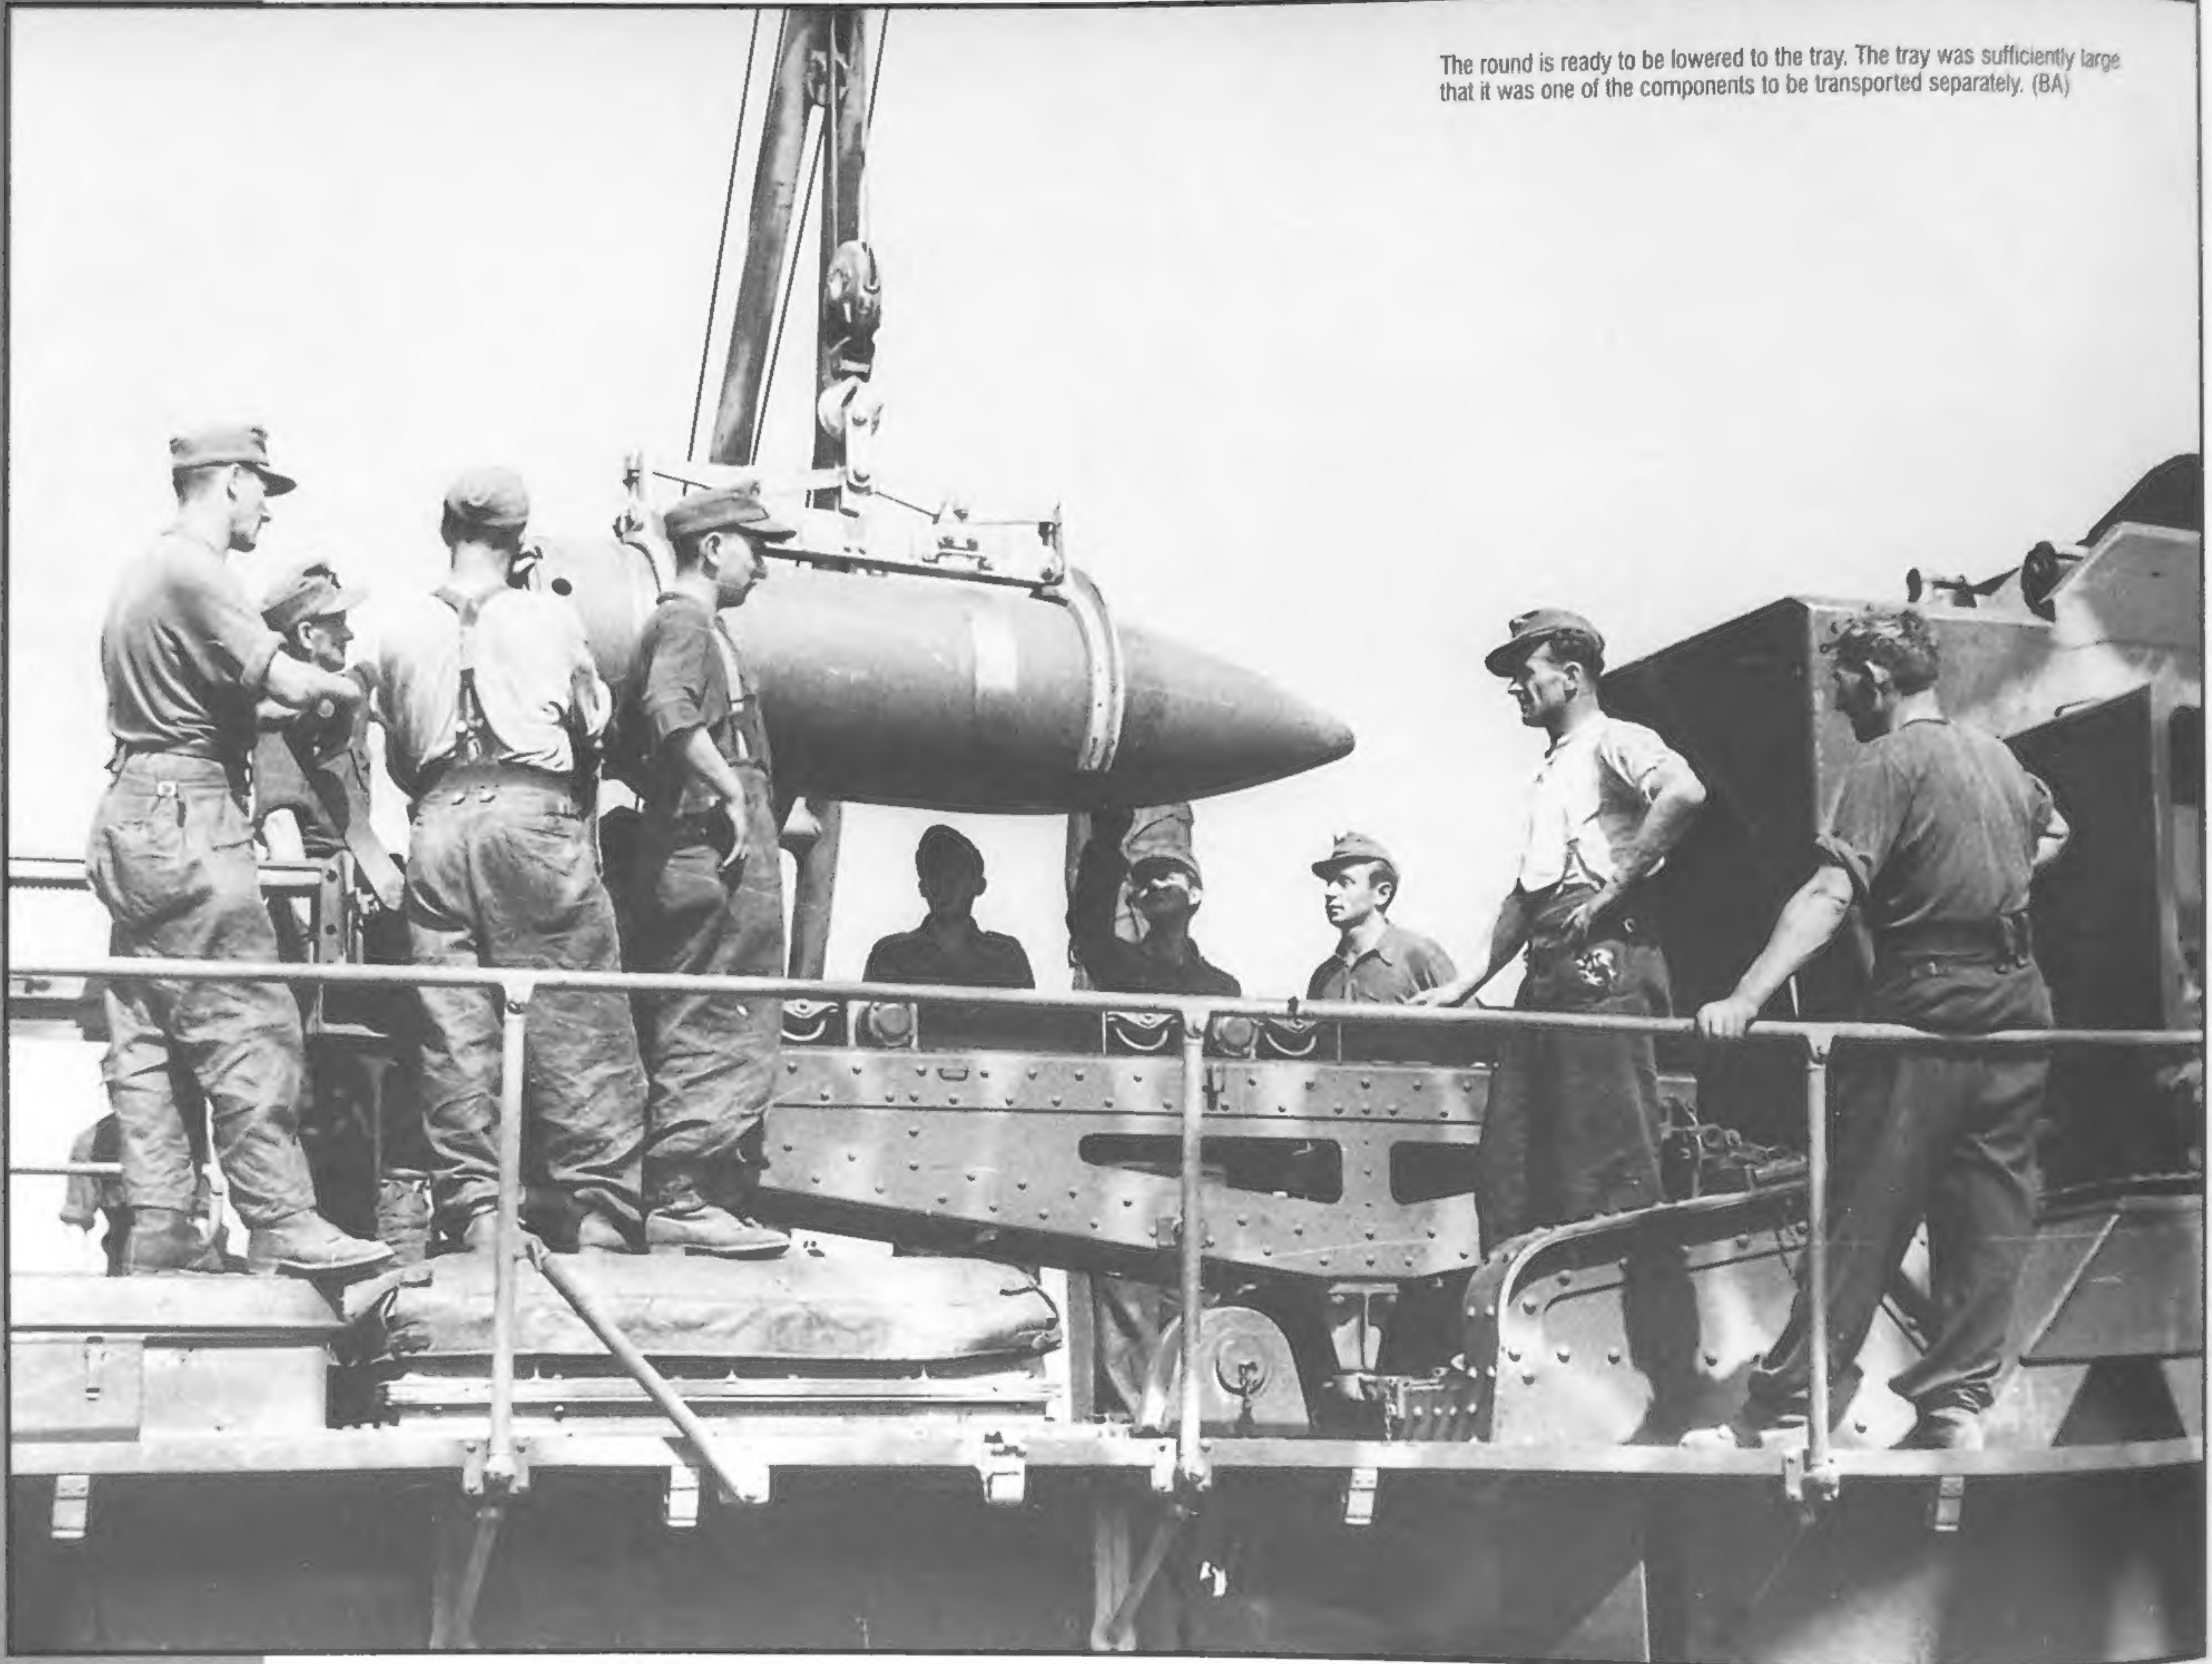
The round is ready to be lowered to the tray. The tray was sufficiently large that it was one of the components to be transported separately. (BA)

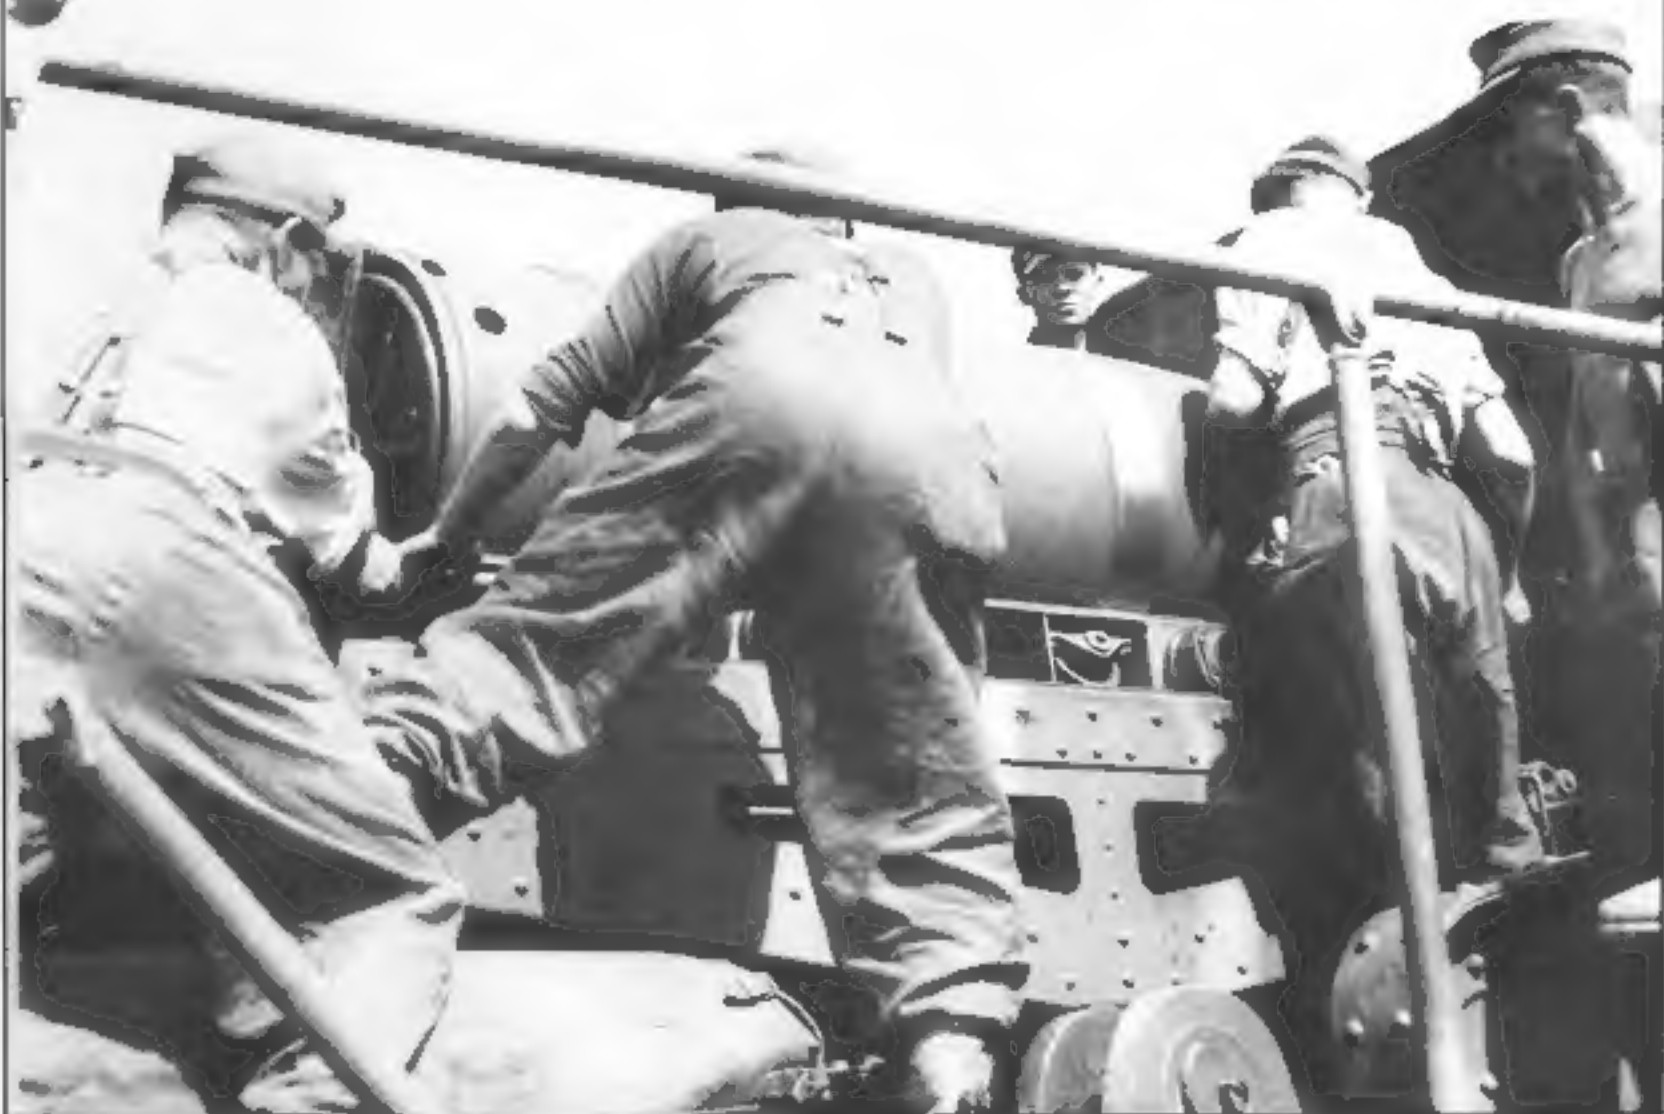
Rollers on the tray allowed the heavy shell to be slid into place in the trough, but it still took the effort of at least six of the crew. (BA)

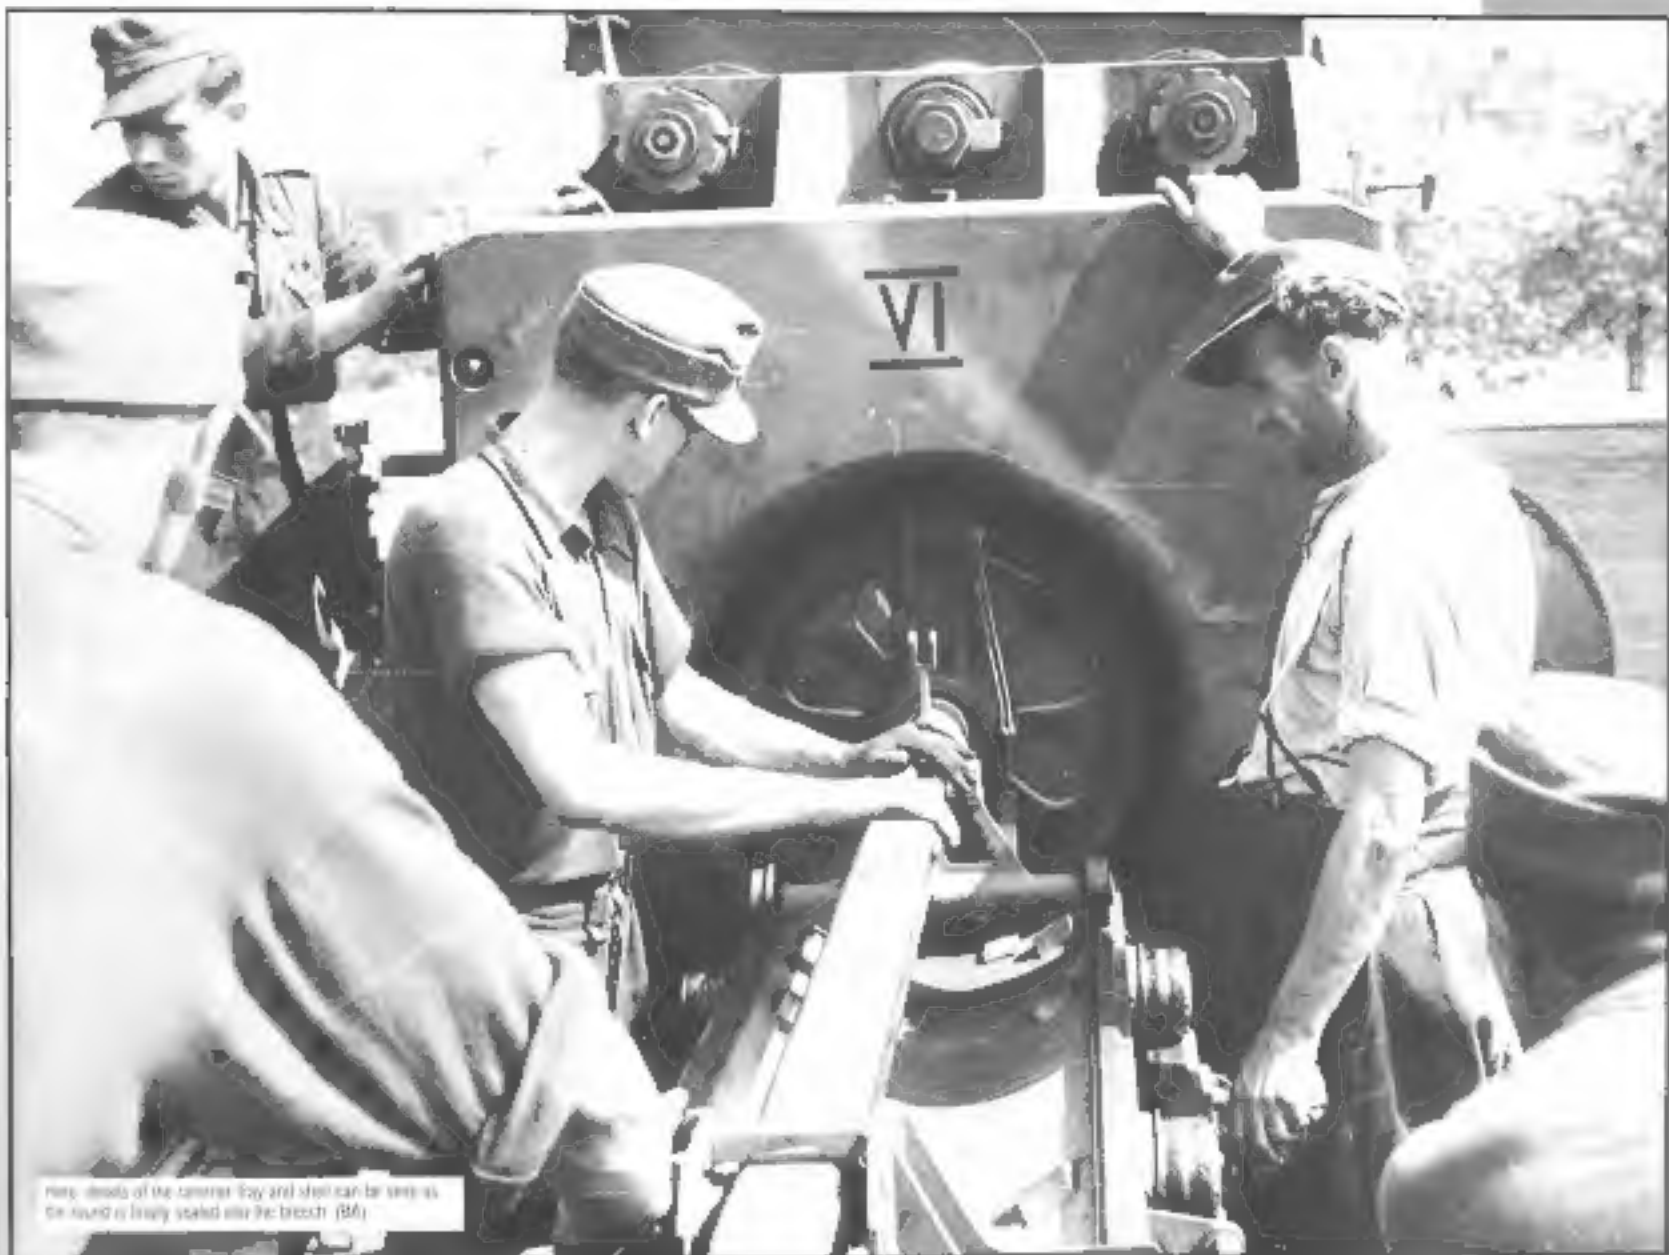
A final check of the round is done and it is also carefully wiped to remove any debris that could foul the rifling of the barrel. The larger round was a "Betongranate," or concrete piercing shell and was filled with 280 kg of explosives. (BA)

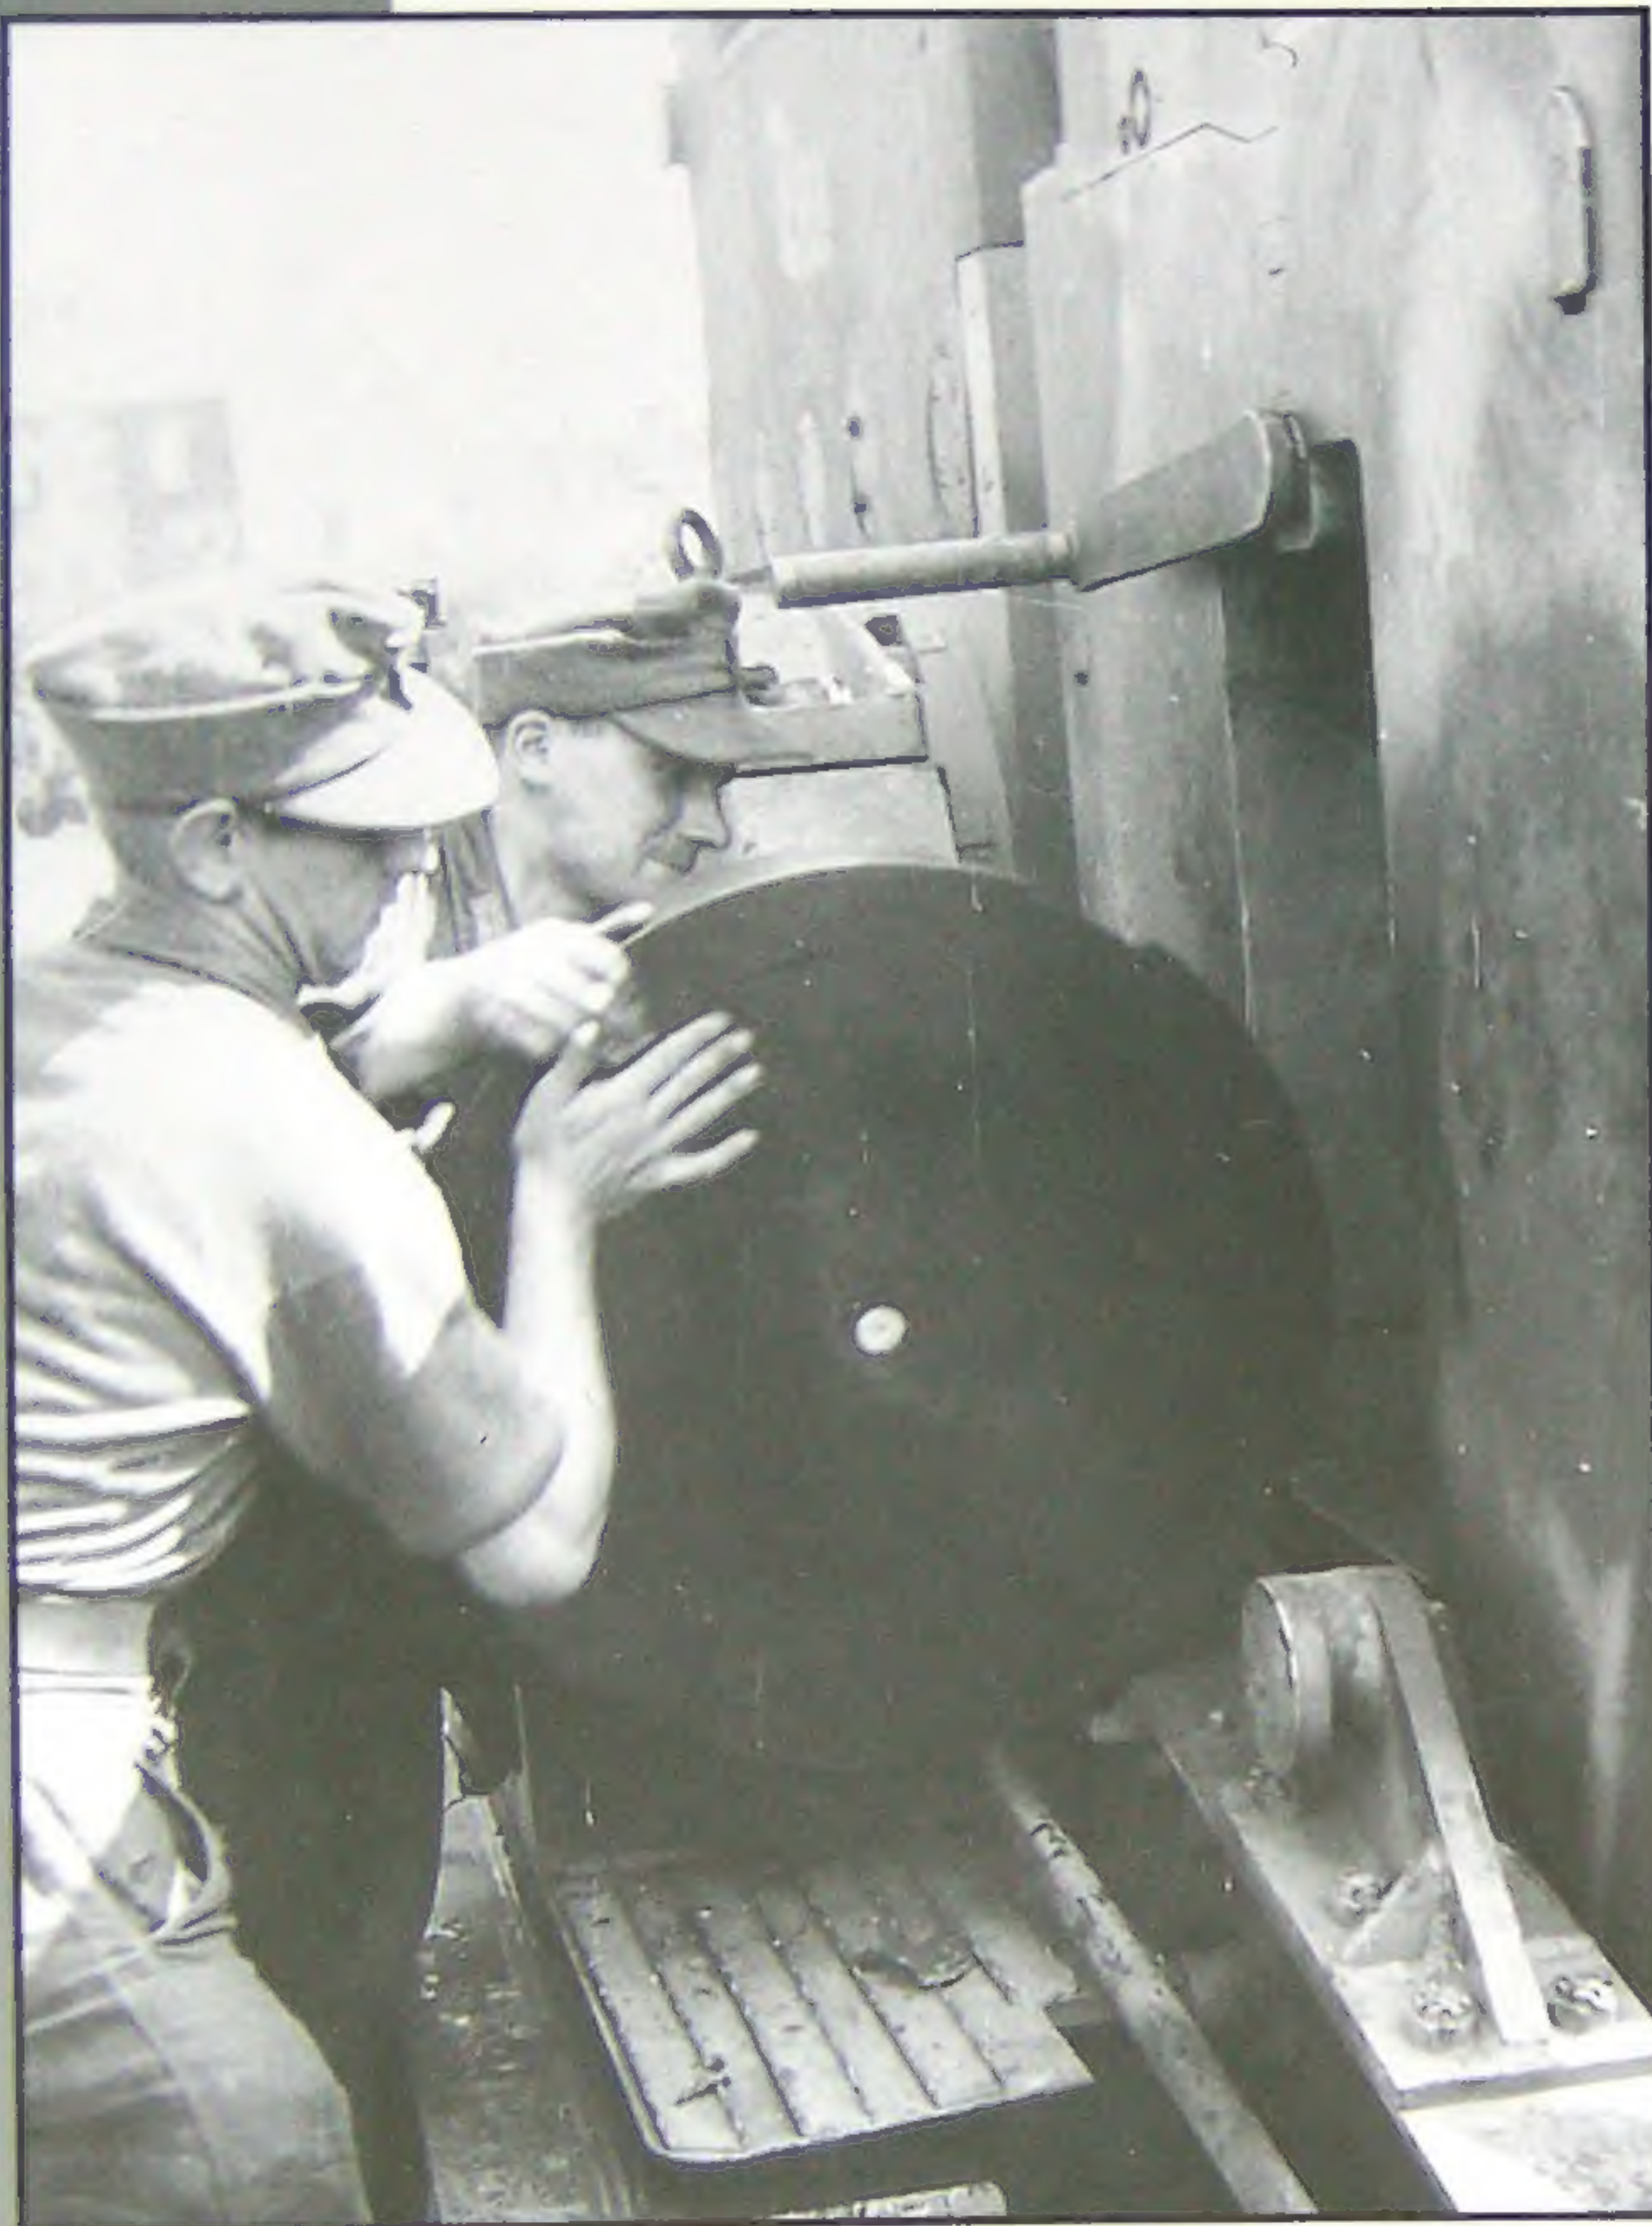
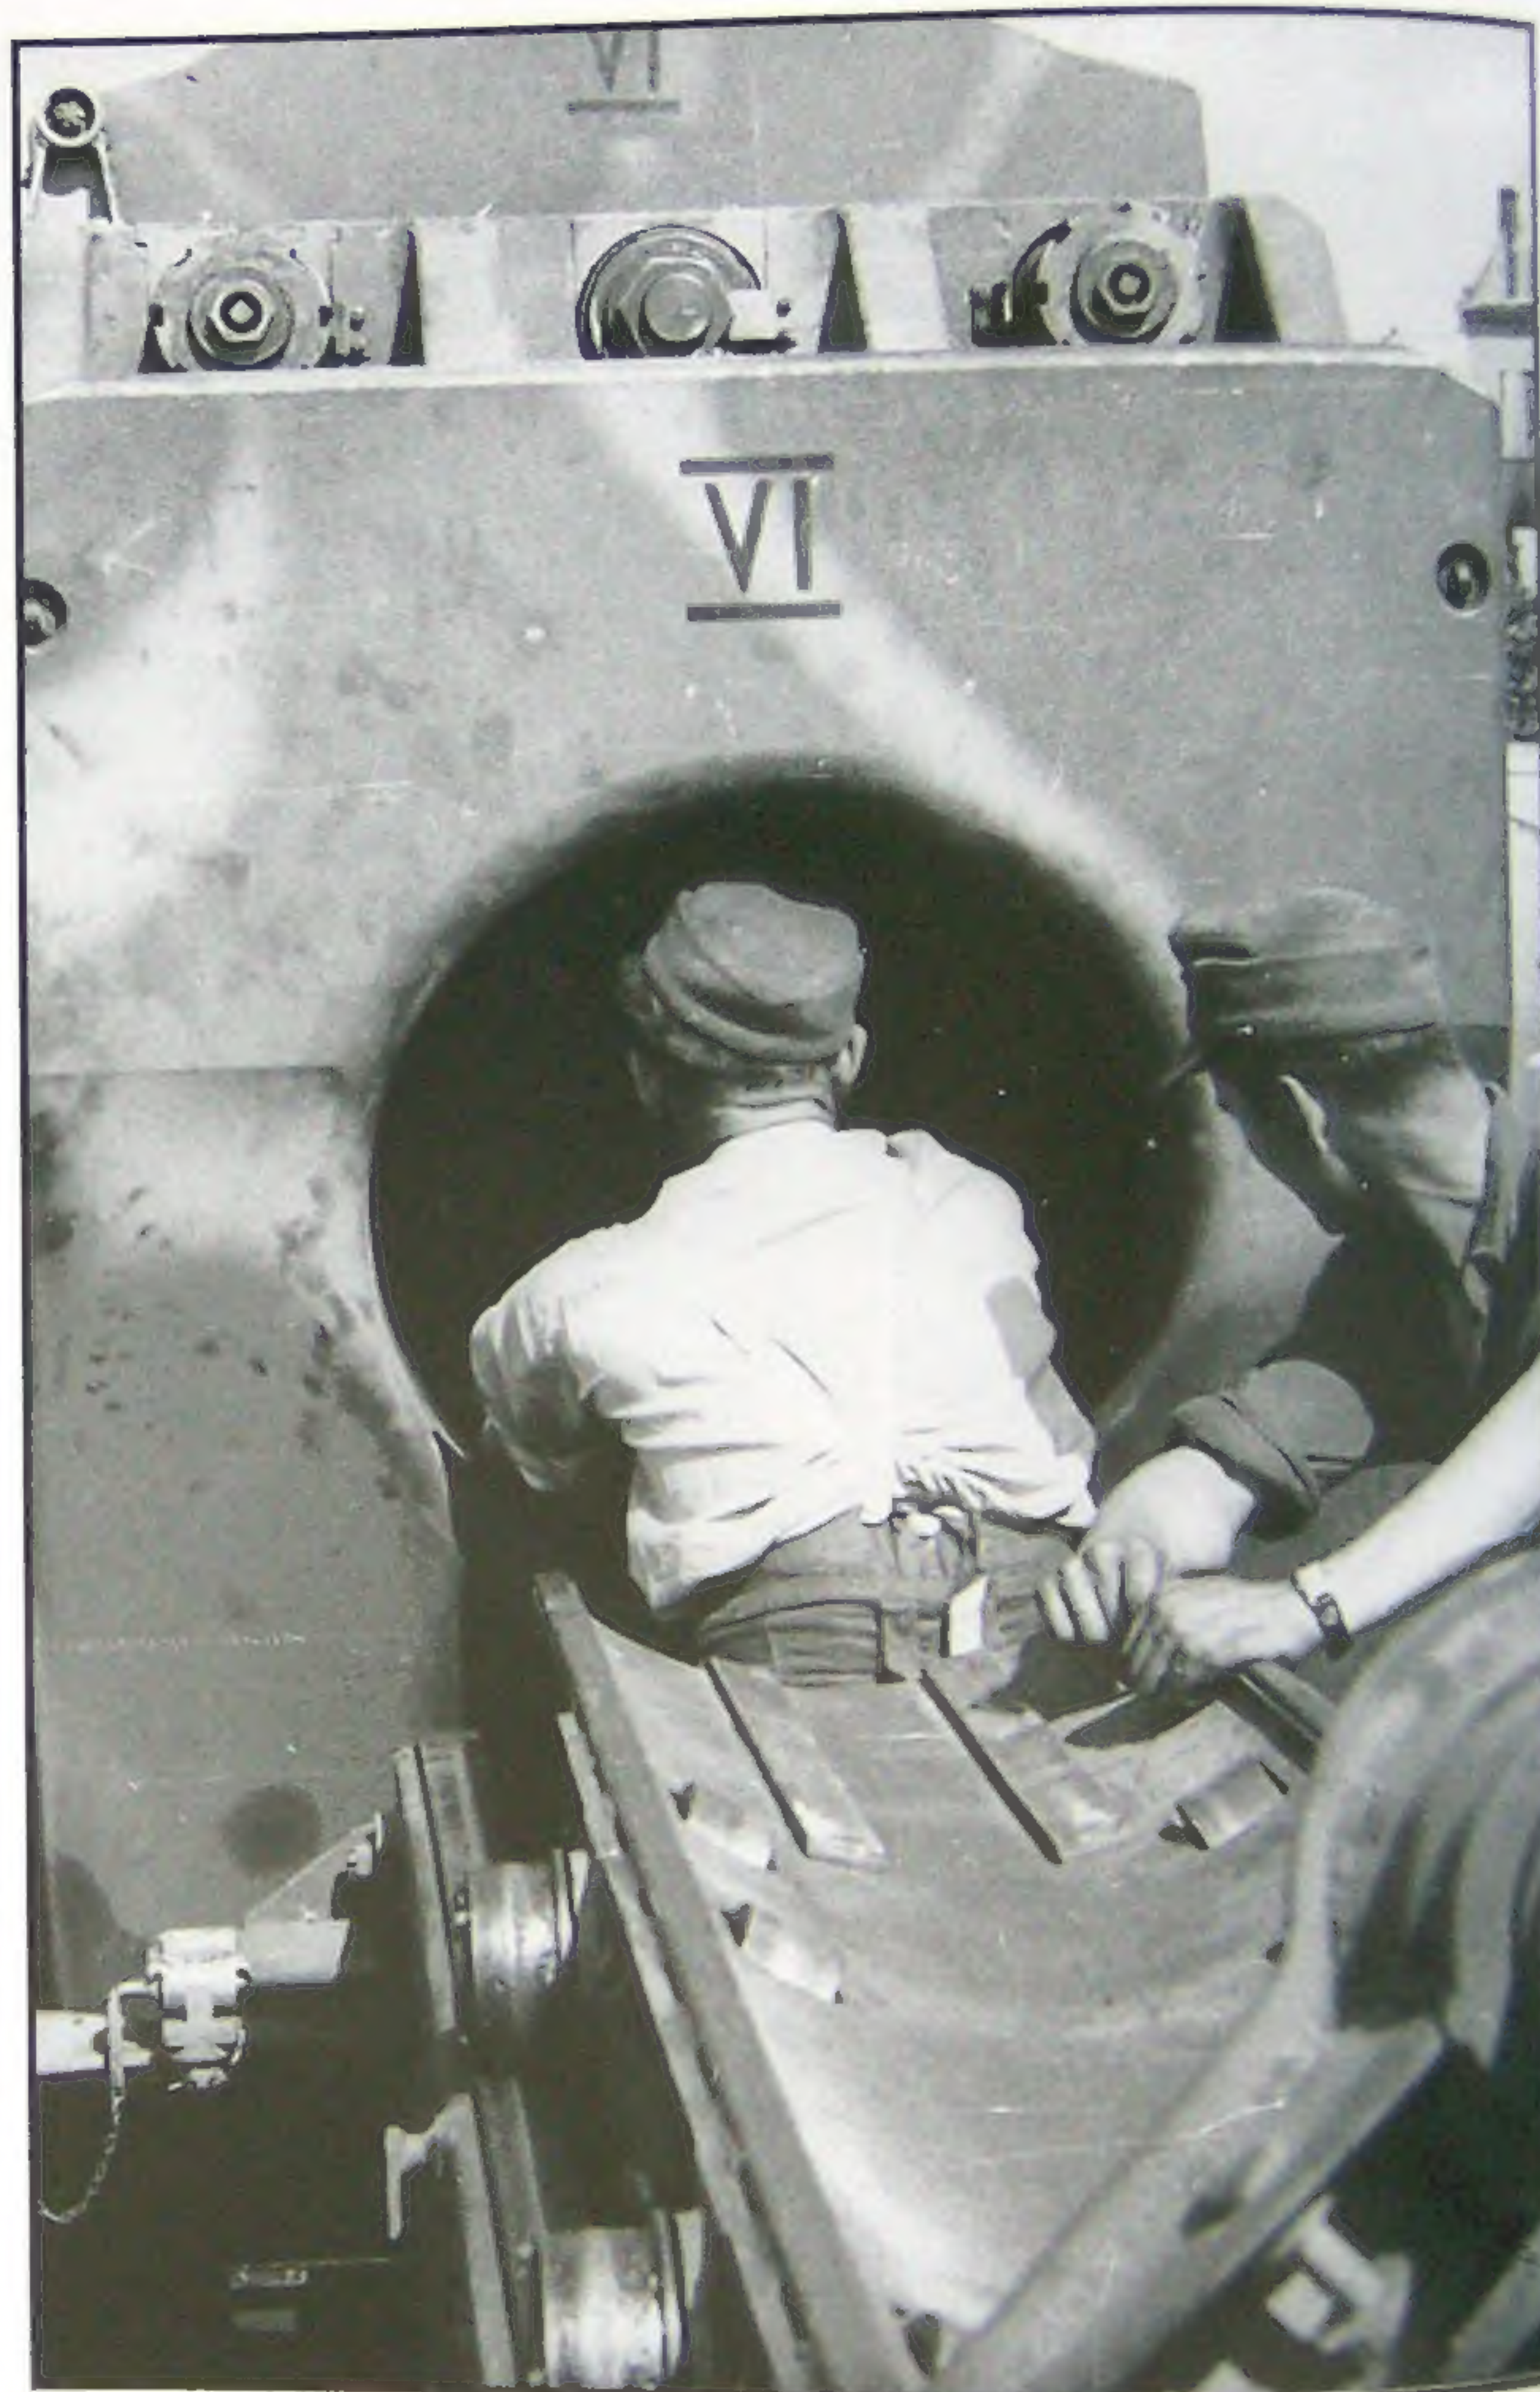
Interestingly, the Karl-Gerat had a separately actuated opening in the side of the breech to receive the charge for the shell. In the left shot, the charge is being added, while in the right shot the crew is checking the seal of the charge against the breech and the shell. Nine different charges were available for either shell type and for example, with charge four in place the concrete piercing shell could achieve a muzzle velocity of 220 meters per second. (BA)

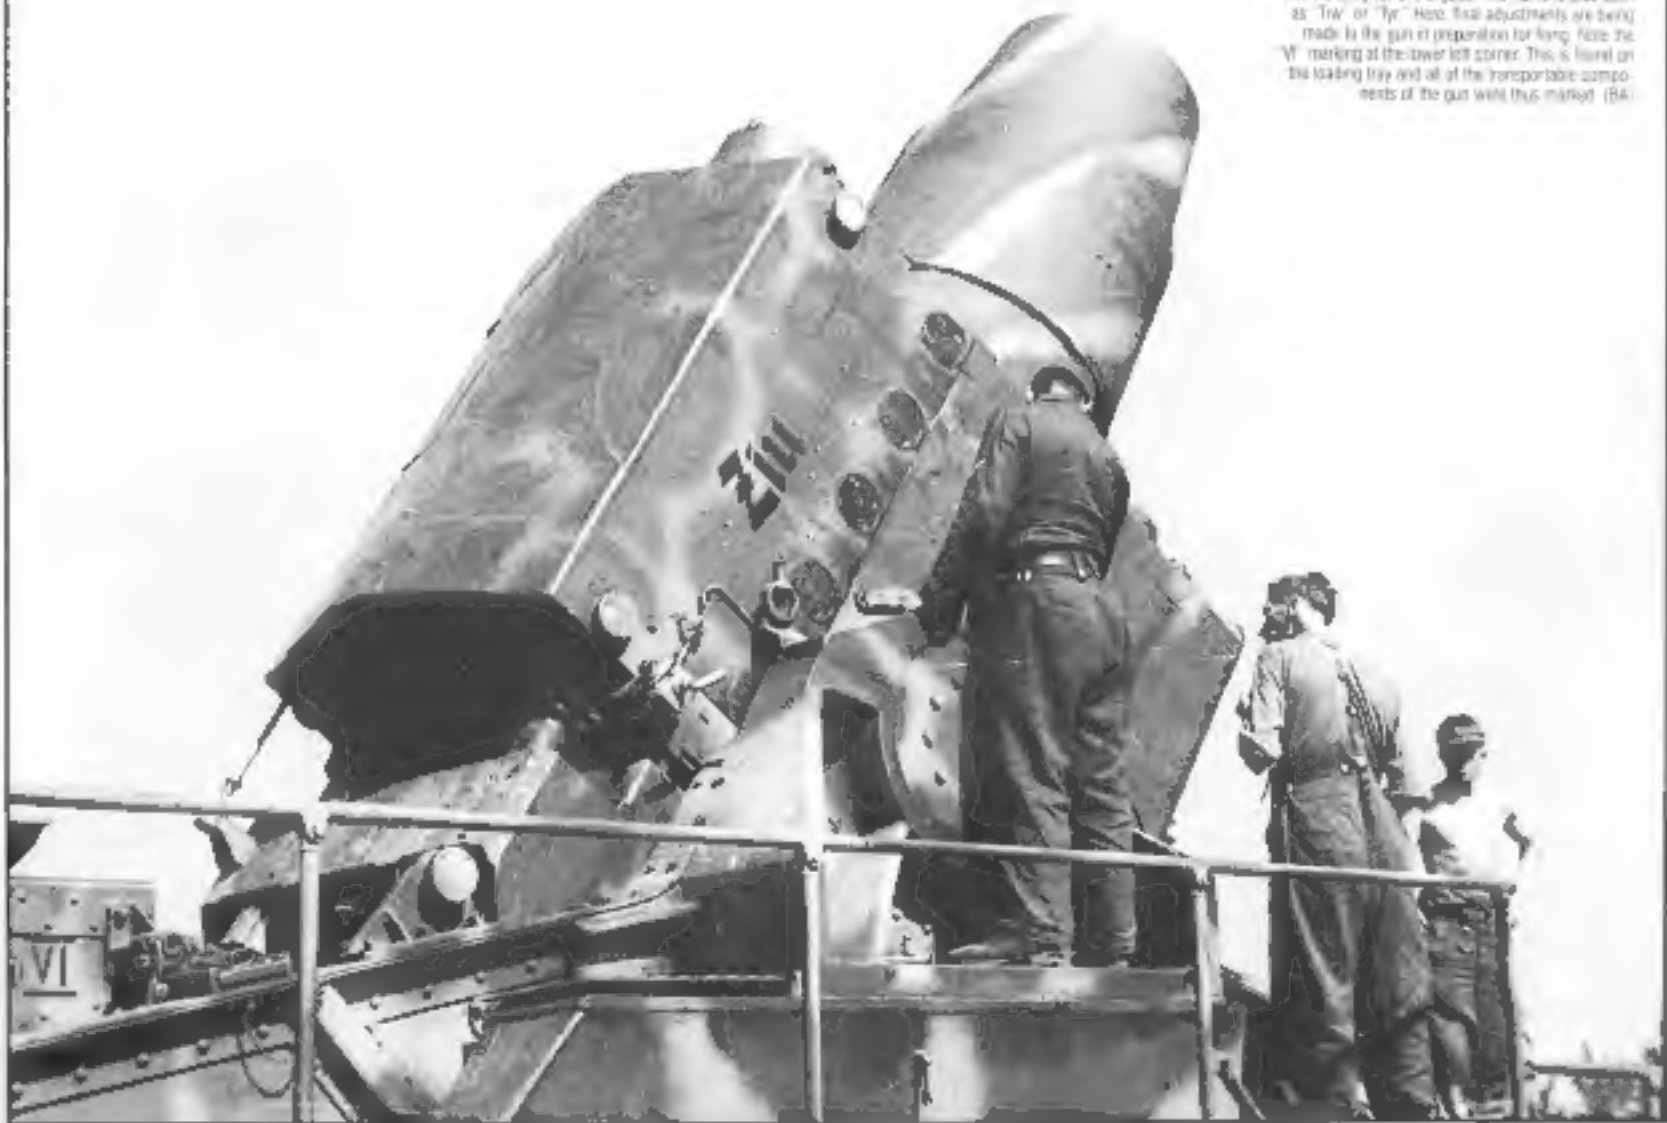
And the Karl-Gerät carried names based on German mythological characters. "Ziu" appears to be a Germanized version of "Ziu", the Norse god of war and the lightning of the gods. The name is also seen as "Tiu" or "Tyr". Here, final adjustments are being made to the gun in preparation for firing. Note the "VI" marking at the lower left corner. This is found on the loading tray and all of the transportable components of the gun were thus marked. (BA)

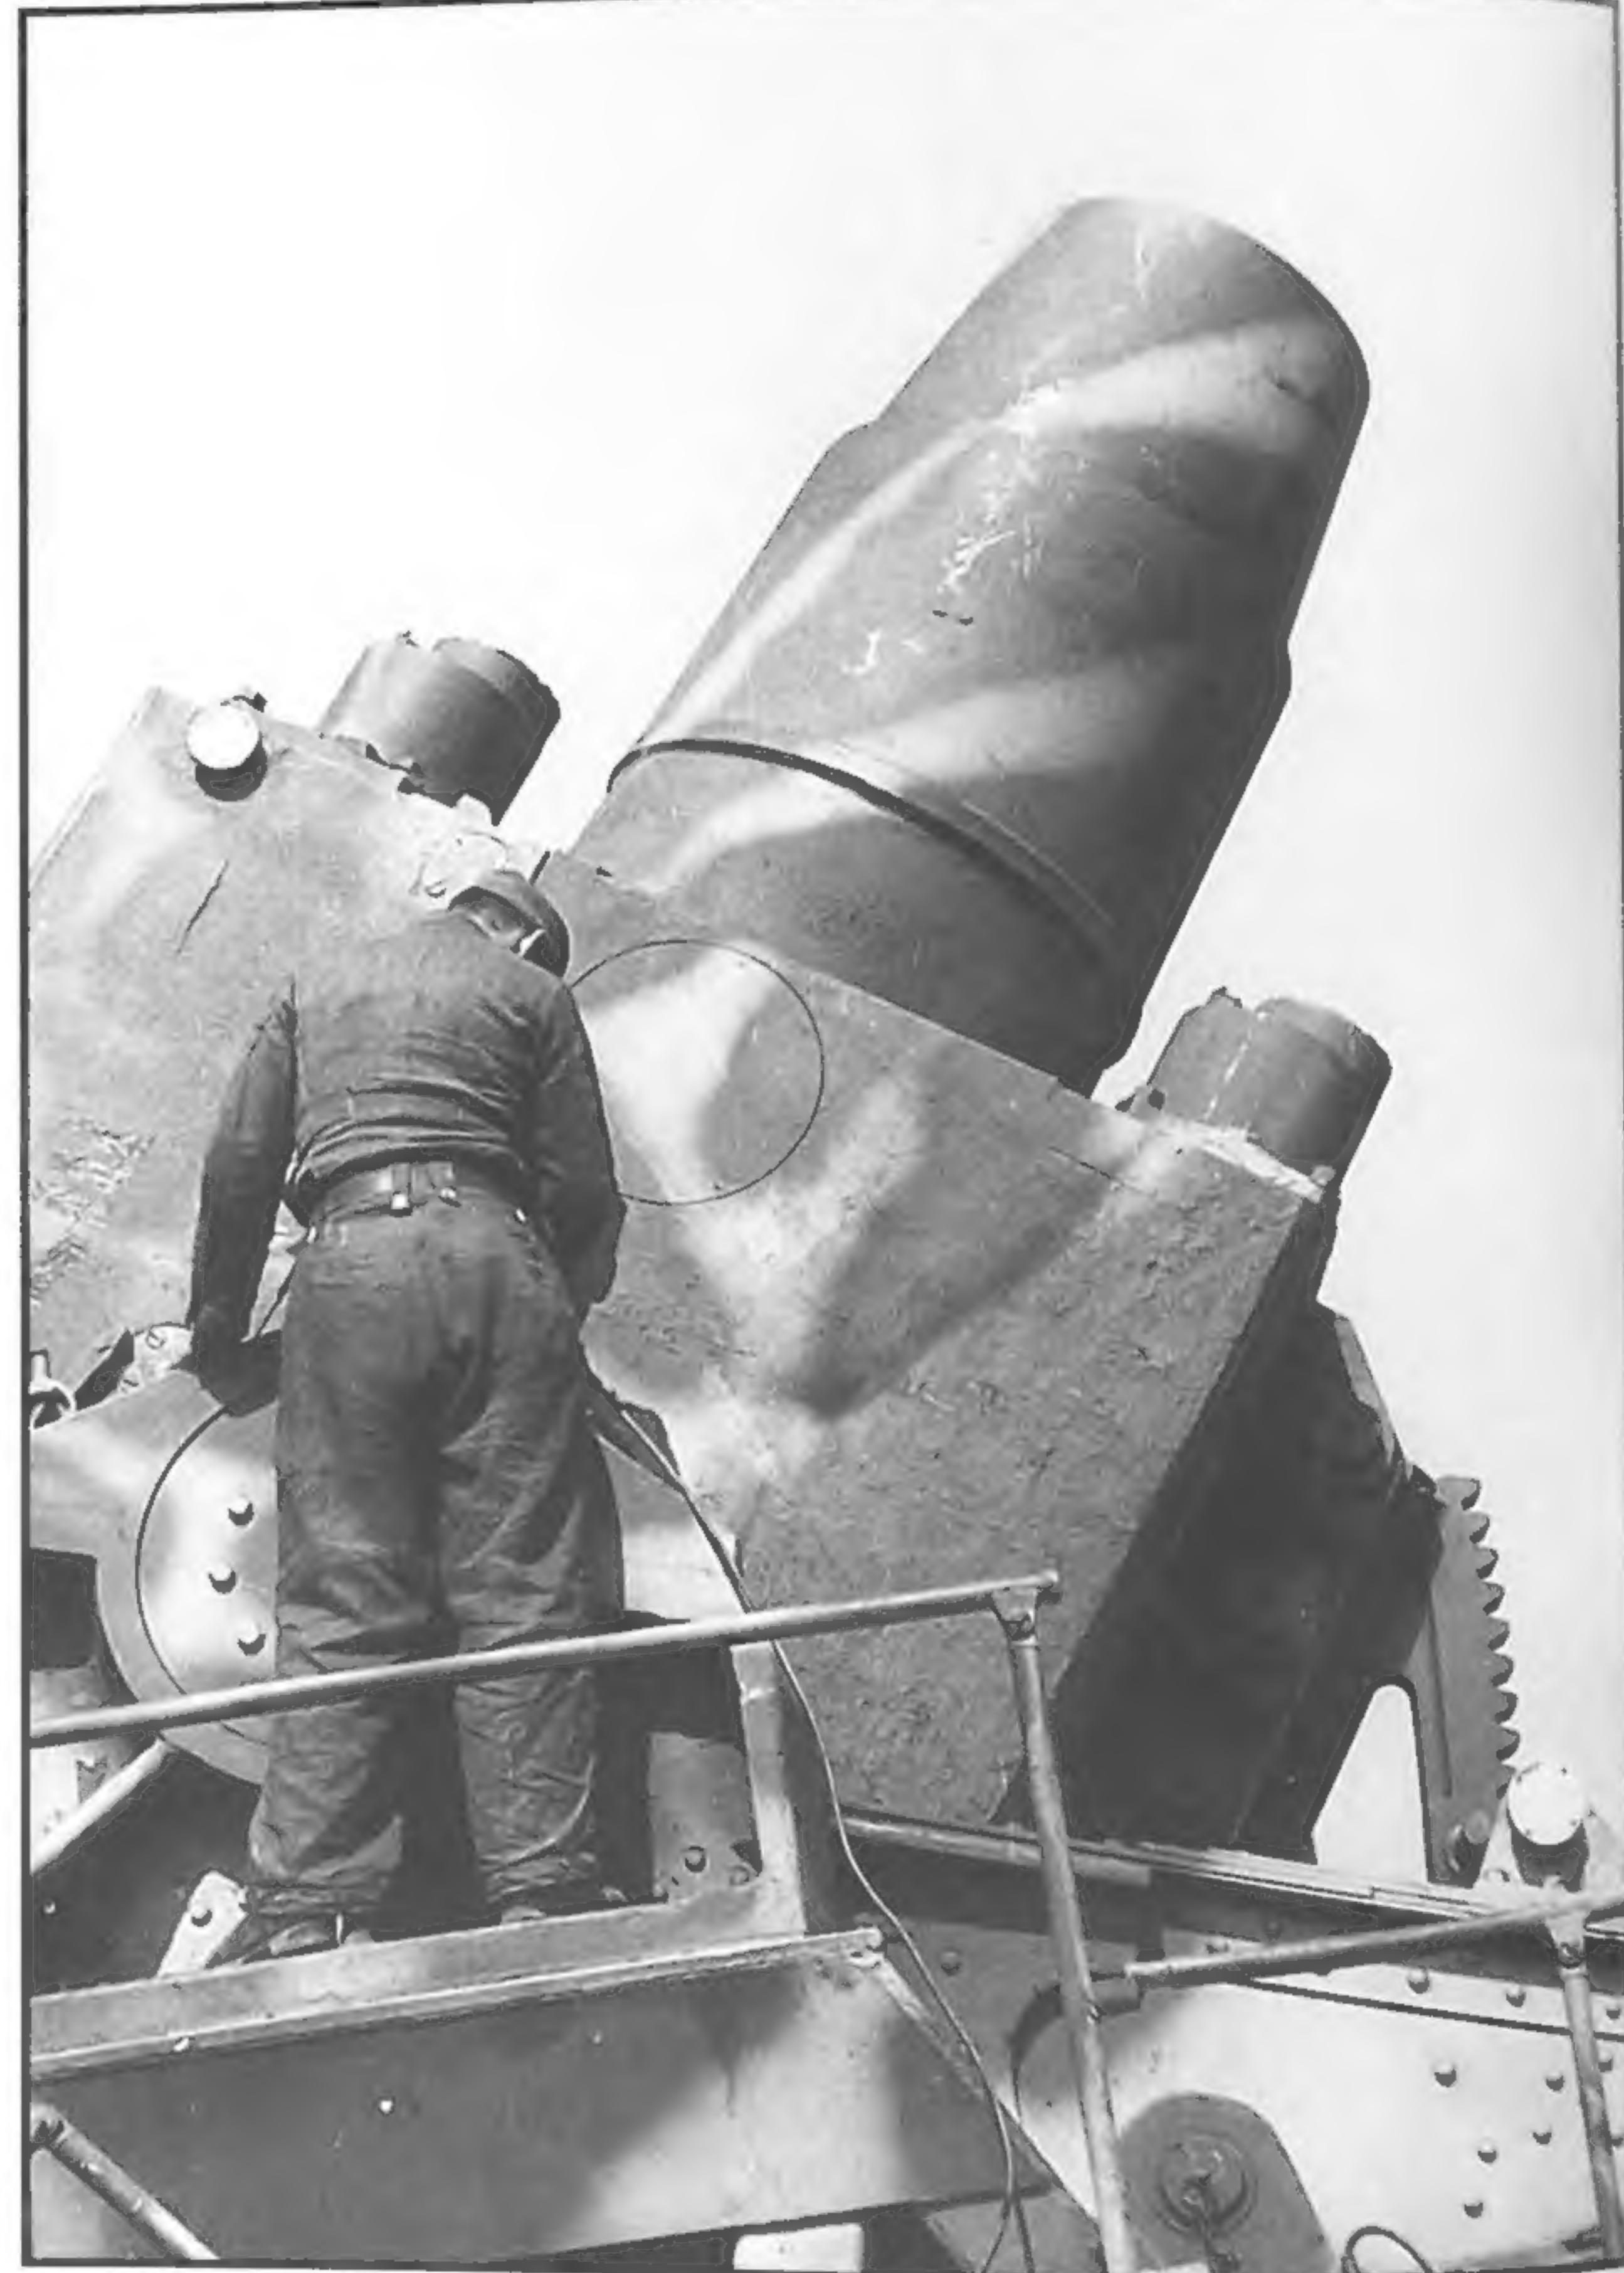
The gun tube length of the Karl-Geral was just over five meters. The gun could elevate between 55 and 70 degrees, but could only be traversed four degrees. Larger adjustments meant moving the entire vehicle. However, using the main engine, the firing platform could be raised and lowered in only 30 seconds. A very careful and precise camouflage pattern has been applied to this gun. (BA)
